MINISTERUL TRANSPORTURILOR ȘI INFRASTRUCTURII  
AGENȚIA DE INVESTIGARE FERROVIARĂ ROMÂNĂ - AGIFER

## ROMANIAN RAILWAY INVESTIGATION AGENCY - AGIFER -

## ANNUAL REPORT 2023

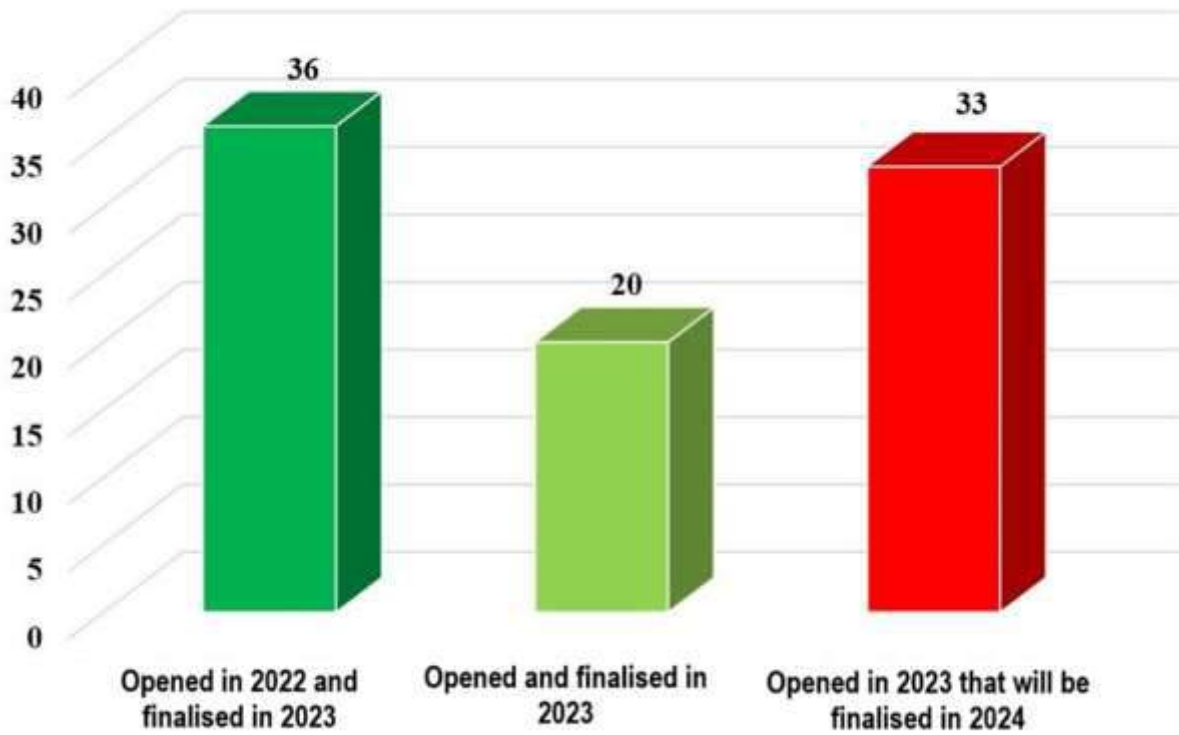
### 2023 INVESTIGATIONS

- **31 rail accidents;**
- **25 railway incidents** classified according to the provisions of Article 8.1 group A of the *Investigation Regulation*, for which the Romanian Railway Investigation Agency ensured the investigator in charge.
